**Subject: Building Valuation and Castaldi Report Analysis of HEC Annex Building
of St. Petersburg College**

SPC Project No.: SPJC-1 0000106319
ARC3 Project No.: 18009

Building Valuation and Castaldi Analysis of HEC Annex Building

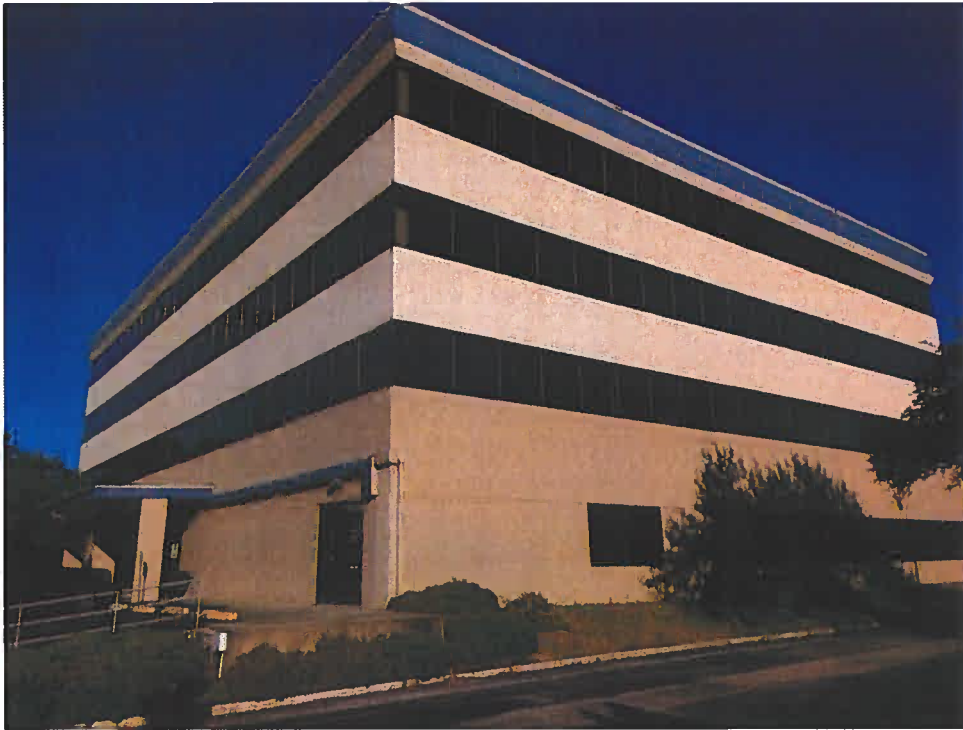
Exhibit B: Precast Concrete and Ribbon Window Facade

The fixed windows are configured in a continuous ribbon wrapping the envelope on four sides. The ribbon windows are not impact rated and are leaking with badly deteriorated glazing seals,

The precast concrete wall panels appear sound with little signs of damage or deterioration.

The existing precast concrete wall cladding is in overall good condition requiring only the application of new paint and sealants.

The ribbon window system is not impact rated and has deteriorated seals allowing water infiltration. The window system would need to be replaced with new watertight, impact rated assemblies.

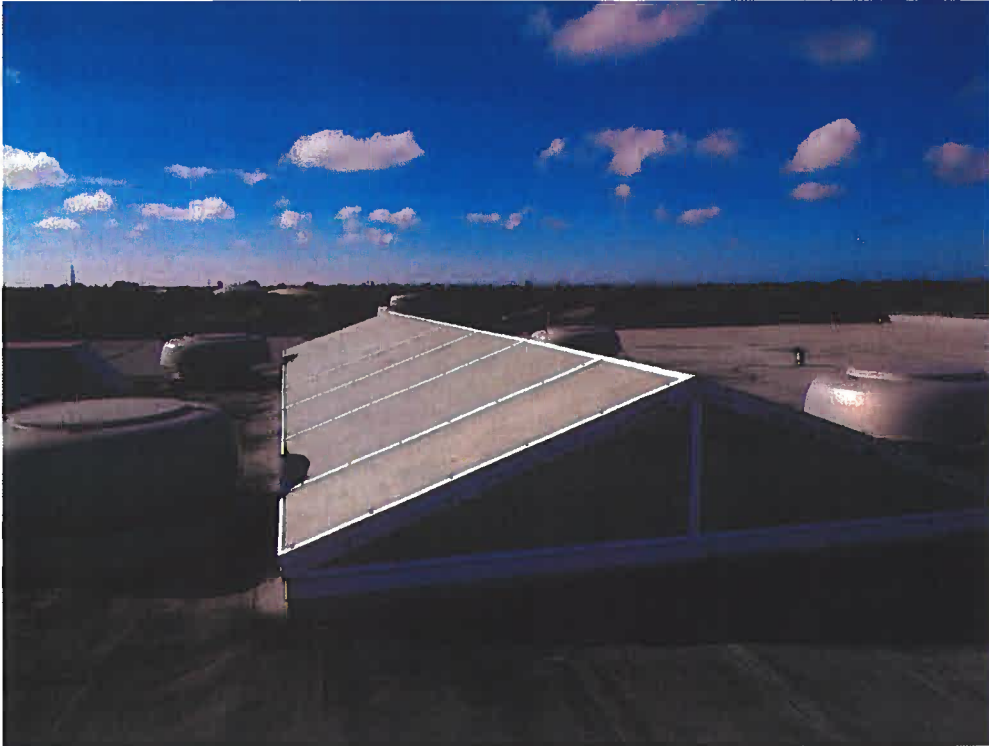
Exhibit G: Roof Skylight

The skylight fiberglass panels have yellowed with age and the assembly is reported by Facilities Management to be leaking.

The non-impact rated skylight that is leaking should be replaced with a new watertight impact rated unit.

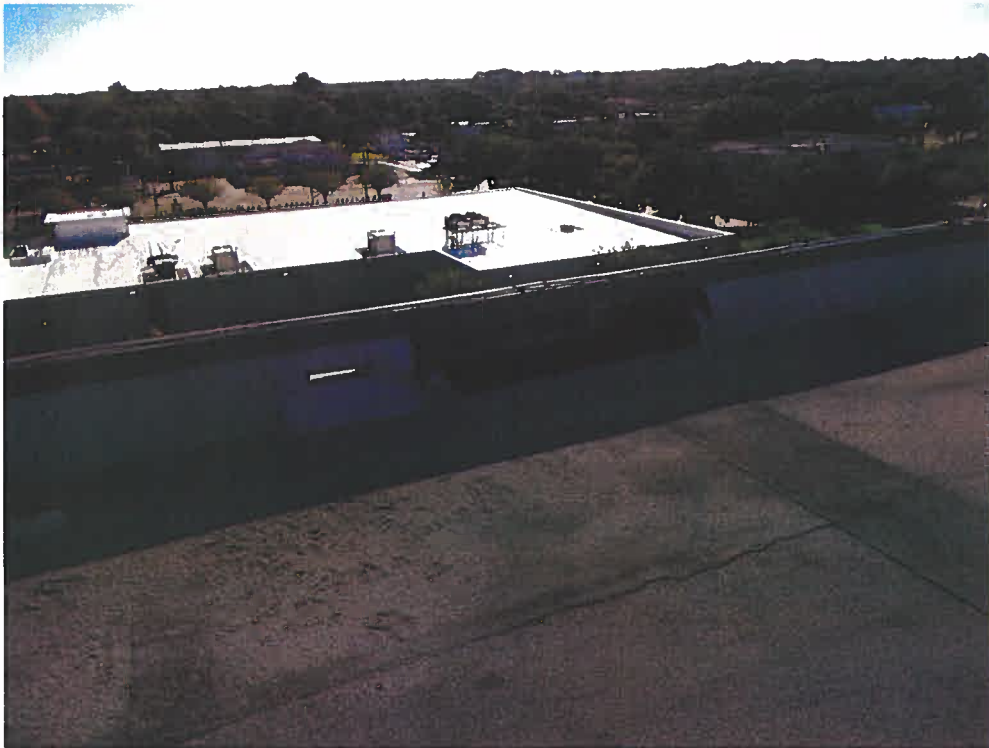
Exhibit H: Damaged Parapet Flashing

The membrane appears in sound condition with no evidence of blisters or deterioration and good coverage of the granular surfacing. There is one location of damaged parapet wall flashing where the flashing has pulled away from the top of the parapet (Exhibit H).

The roofing membrane and perimeter parapet metal flashings, although in overall sound condition, have been in place for the bulk of their expected service life and should be replaced as a component of a general building renovation with a requirement for a twenty (20) year warranty.

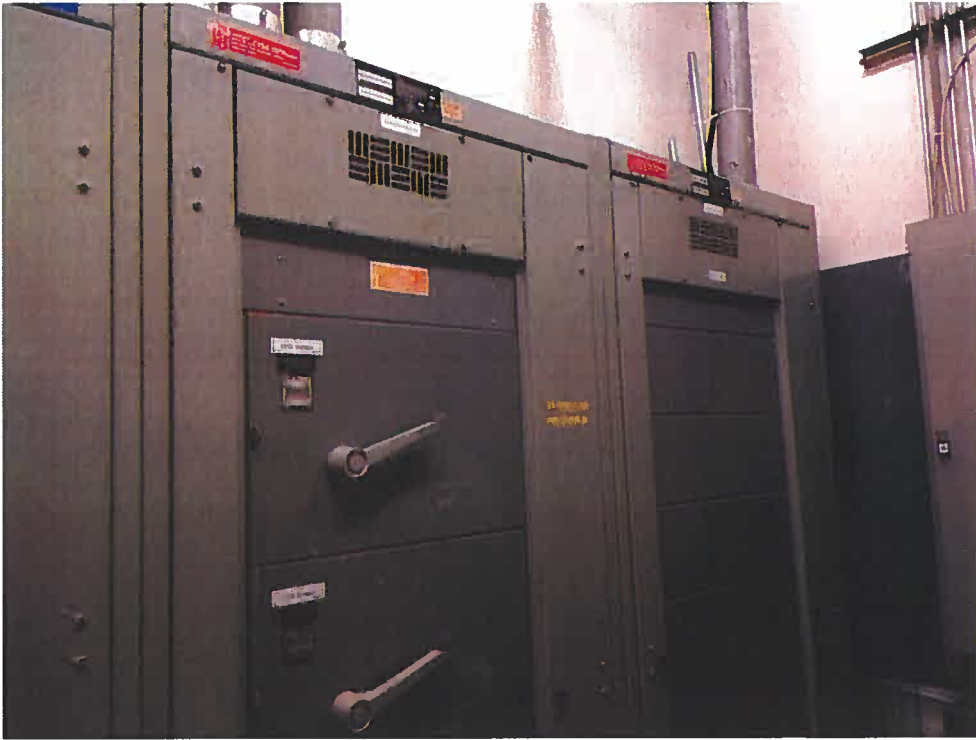
Exhibit M: Main Switch Gear

The basic electrical infrastructure appears to be in fair condition, given its age of roughly 30 years. Although the equipment has been kept in fair condition, the panels and breakers are an older style no longer manufactured (Westinghouse). The availability of parts would continue to become increasingly difficult.

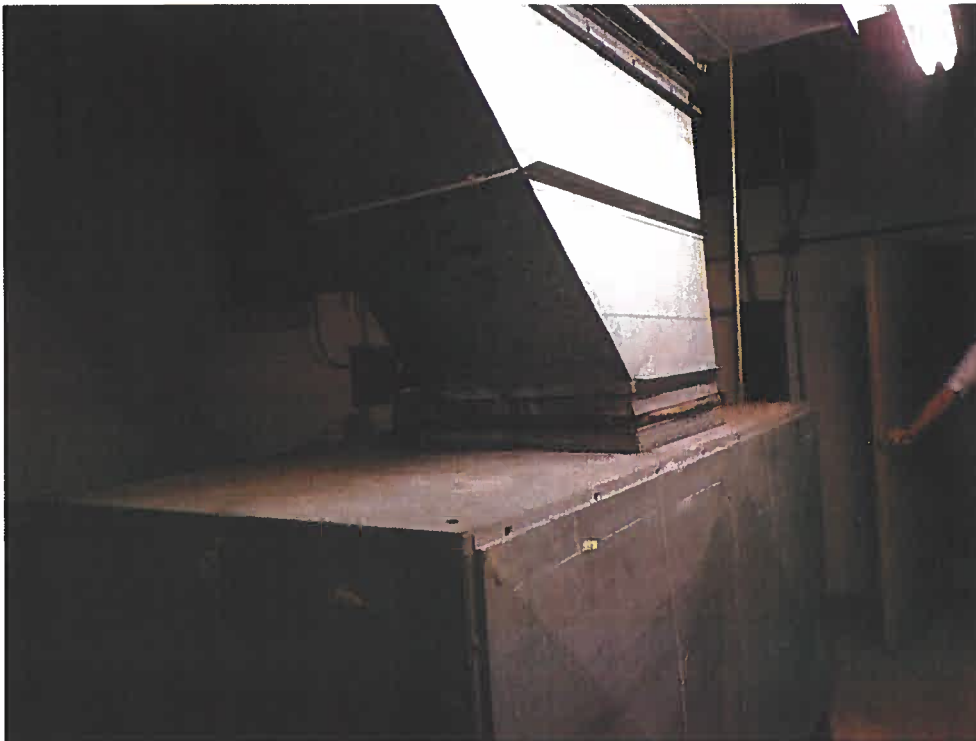
Exhibit N: Typical Air Handler

The existing AHUs are in poor condition and showing significant amounts of rust and degradation both inside and out. These units are at the end of their useful life and should be expected to be replaced.

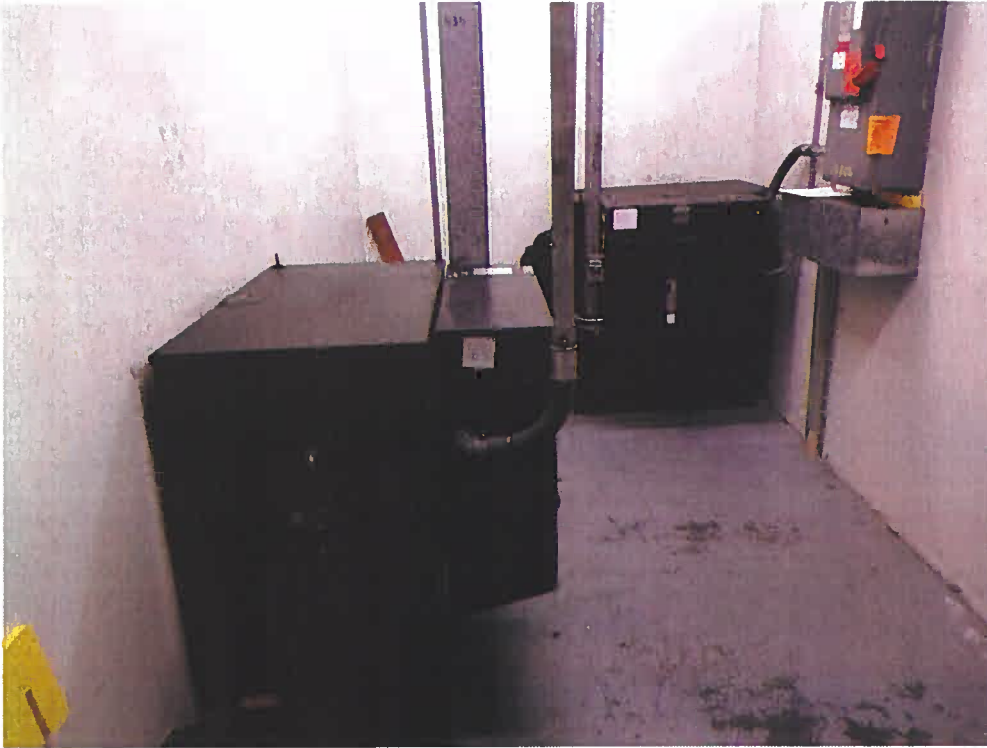
Exhibit O: Elevator Hydraulic Pumps

The building currently employs two hydraulic elevators located in the main atrium lobby. These elevators appear to be original to the building and have not been in use.

The hydraulic elevators and associated hydraulic pumps are original to the building, circa 1984, and have been unused and locked down for the duration of the occupancy of the building by the College. This equipment should be evaluated to determine condition and refurbished/replaced as recommended by the firm performing the evaluation.

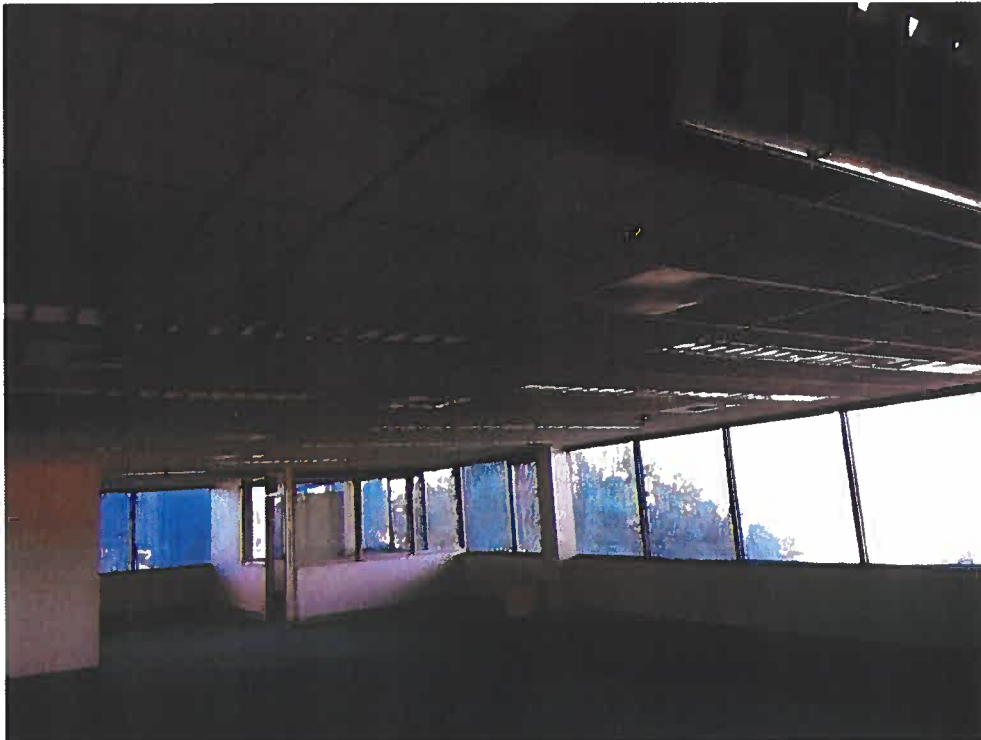
Exhibit P: Typical Upper Floor Office Build-Out

The upper floor interior build-out is the original office configuration from the period prior to acquisition by the College (Exhibit P). Vinyl wall covering on the exterior walls has delaminate in multiple locations throughout the upper floors (Exhibit Q). Damage caused by water infiltration at the ribbon windows has been addressed by performing selective demolition of the furred wall finish below the windows in multiple locations throughout the upper floors (Exhibit R).

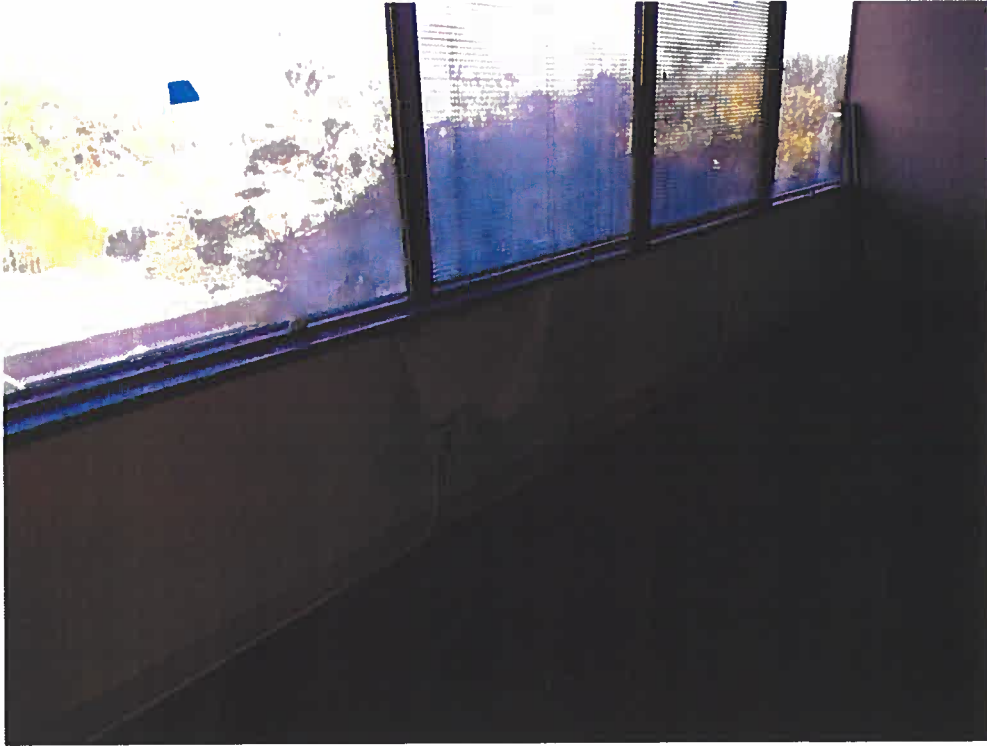
Exhibit Q: Typical Example of Vinyl Wall Covering Delamination at Point of Water Infiltration

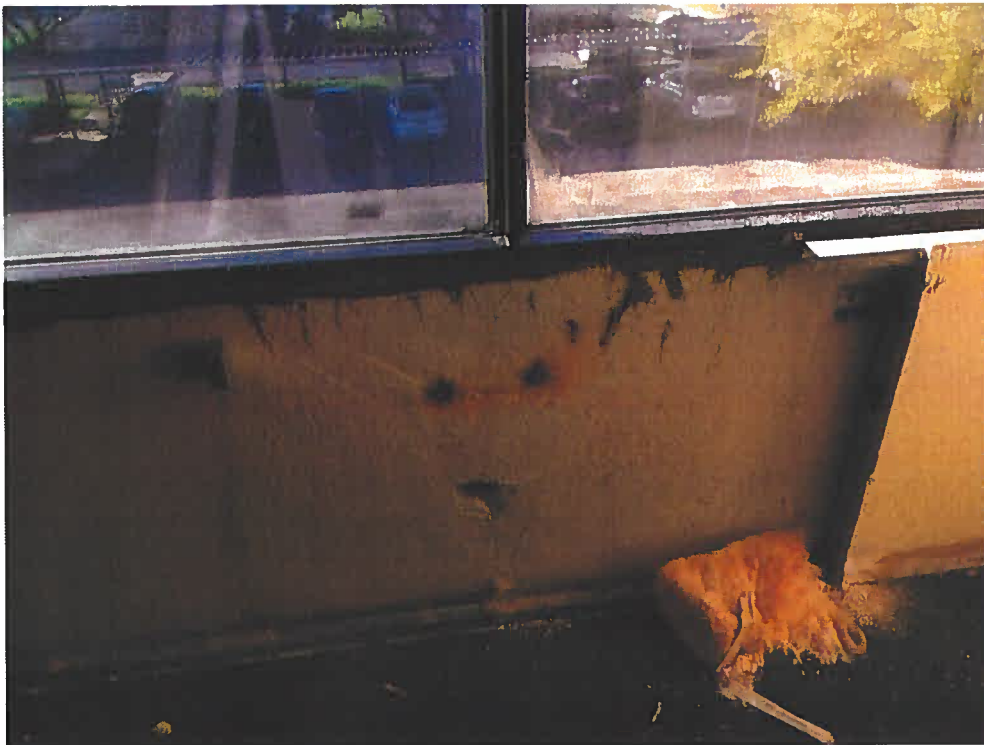
Exhibit R: Typical Example of Minor Demolition at Locations of Water Infiltration
